Drinking Water Audit Report

County:	Mayo	Date of Audit:	23 February 2016
Plant(s) visited:	Swinford WTP	Date of issue of Audit Report:	7 March 2016
		File Reference:	DW2014/14
		Auditors:	Ms Derval Devaney Ms Michelle Roche
Audit Criteria:	<ul style="list-style-type: none"> • The <i>European Union (Drinking Water) Regulations 2014 (S.I. 122 of 2014)</i>. • The <i>EPA Handbook on the Implementation of the Regulations for Water Services Authorities for Public Water Supplies (ISBN: 978-1-84095-349-7)</i> • The recommendations specified in the <i>EPA Drinking Water Report</i>. • EPA Drinking Water Advice Notes No.s 1 to 15. • The recommendations in previous audit reports.

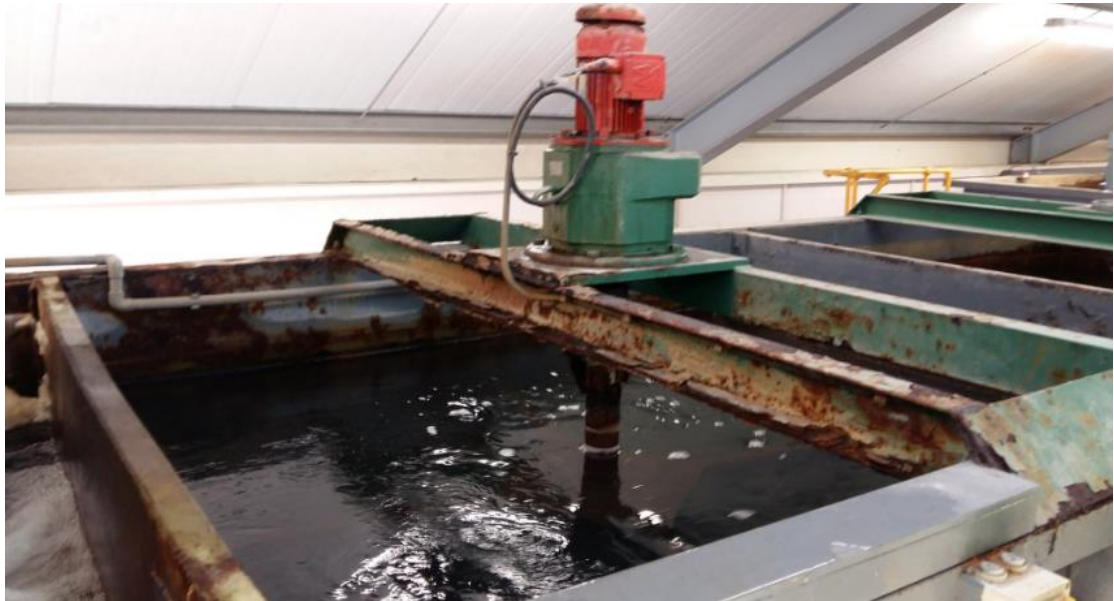
Photo 1 Rust on 1st contact tank

- (d) ensure the contact tank is inspected and maintained on a regular basis so that it is free from rust and structurally sound.

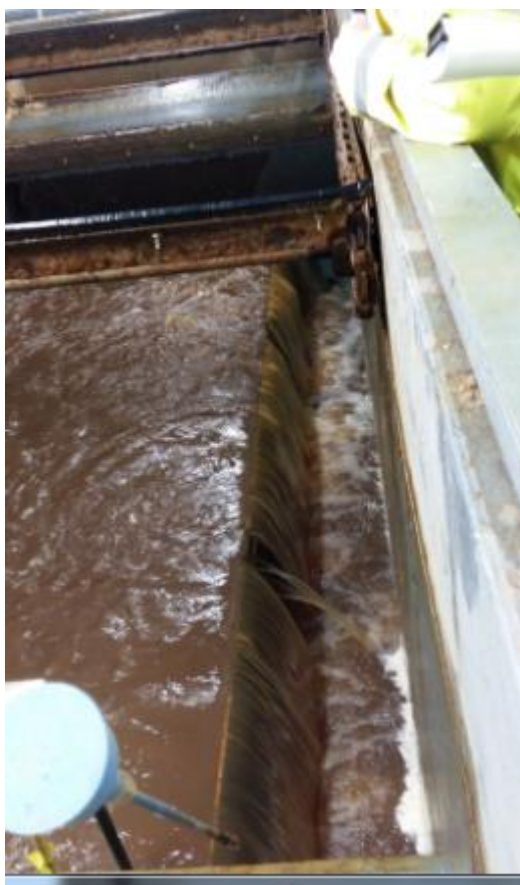
Photo 3 Backwash on DAFF Unit No 1 – water escapes via gap in weir

- 5. Irish Water should investigate if the backwash water escaping through a gap in the raised weir wall of DAFF unit No. 1 during the initial backwashing period is causing a loss of filter media or preferential flow and/or uneven scouring during backwash.
- 6. Irish Water should review the suitability of the current location of the final water turbidity monitor (post the reservoir) to ensure it affords the caretaker time to react in the event of excessive turbidity in the final water.
- 7. Irish Water should review the operation of the filters to ensure that the levels of turbidity in the filtered water are as low as possible and no greater than 0.5 NTU. If there is a risk of the presence of *Cryptosporidium* in the raw water, then the turbidity of the filtered water should not exceed 0.2 NTU.
